# Vehicle Inspection Report

(#352027)

| Model | Mustang GTA S Code 390 Convertible |

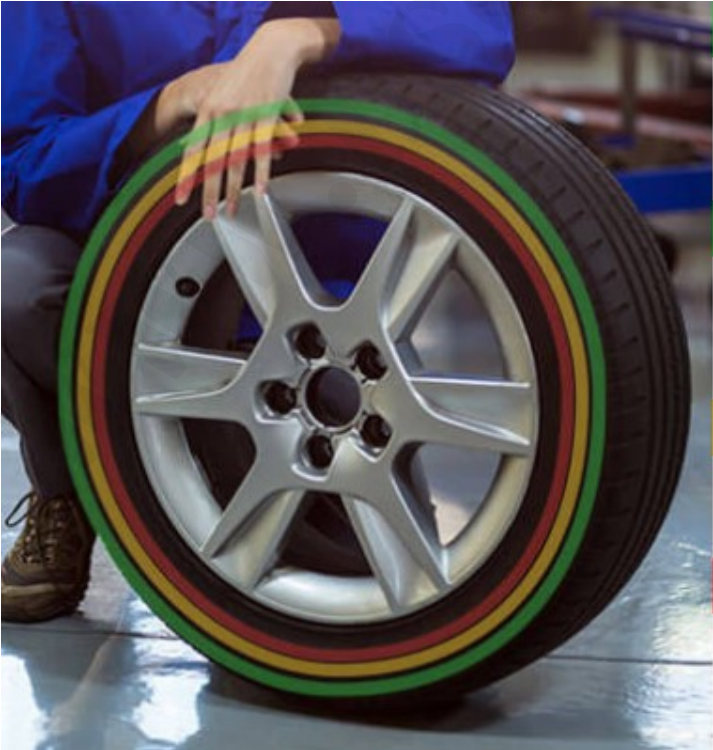
10/32 OR MORE

Tires have plenty of tread!  
(standard)

Tires will need replacement soon!

4/32 OR LESS

Tires need replacement!
